STRUCTURAL DEGRADATION AND DAMAGE CAUSED BY A SYSTEM OF CRACKS TO THE STEEL OF METALLURGICAL EQUIPMENT

P. V. Yasnii,¹ P. O. Marushchak,^{1,2} I. V. Konovalenko,¹ and R. T. Bishchak¹

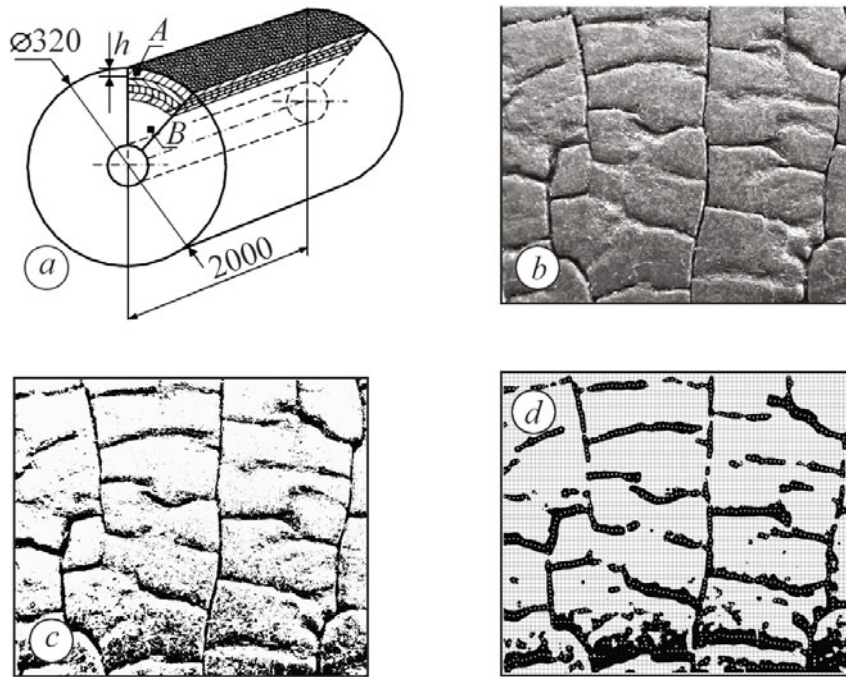
We study a fragment of an MCCB roller made of 25Kh1M1F steel. The roller was removed from operation at the “Illich Integrated Iron & Steel Works” (Mariupol) due to the appearance of cracks on its working surface as a result of thermal fatigue caused by periodic contacts with the metal heated to a temperature of 1100–1200°C followed by cooling in the atmosphere of water vapor. The temperature of its surface varied within the ranges 450–670°C in the contact zone and 100–375°C in the cooling zone [1]. The specimens were cut out from the roller to guarantee the possibility of analysis of its structure in the zone of thermal cyclic loading A (Fig. 1) at a depth of up to 5 mm from the outer surface. For this purpose, we used an Axiovert-40MAT metallographic microscope (Carl Zeiss).

Fig. 1. Analysis of the cracked surface of the MCCB roller: (a) schematic diagram of cutting out the specimen, (b, c) original and binary images of the cracked surface, respectively, (d) fragment of the recognized image.

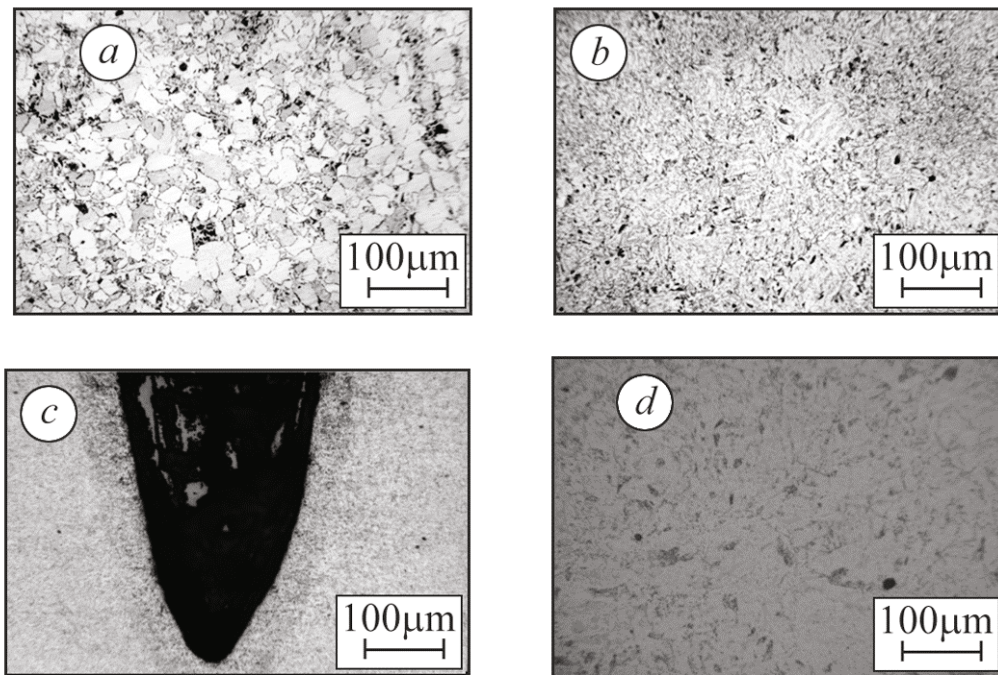
In the intact state, the structure of 25Kh1M1F steel is ferritic-pearlitic with clearly pronounced grain boundaries (Fig. 2a). After operation, the material of the surface layer of the roller at depths of up to 5.0 mm is characterized by the presence of scattered defects and fuzzy interphase boundaries. In the bulk of ferritic grains and on their boundaries, the carbide particles become spheroidal (Fig. 2b).

The exhaustion of plasticity of the material promotes the initiation and coalescence of microdefects in several slip planes which, in turn, leads to multiple crack formation [10, 11]. The analysis of metallographic sections of the subsurface layers performed with the help of an optical microscope shows that the structure of the material in the vicinity the fatigue crack is similar to the structure of the surface layer of the roller (Figs. 2b and d). We also reveal a zone of accumulation of local strains in the vicinity of the crack front (see Fig. 2c).

Fig. 2. Structures of 25Kh1M1F steel ($\times 200$) in the intact (a) and degraded (b–d) states.

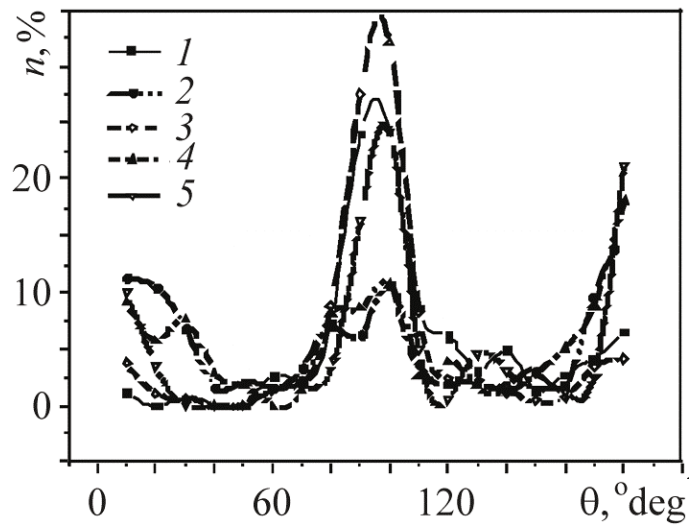
The scaling reproducibility of the location and sizes of the cracks reveals the presence of structural formation under the conditions of self-organization typical of inhomogeneous media. The elements of the digital matrix enable us to describe the structural transformations of the system of cracks in the course of operation [9]. It is shown that, for all studied situations, more than 70% of cracks are oriented in mutually perpendicular directions ($\theta = 0.90^\circ$) (Fig. 3).

Fig. 3. Predominant orientation of thermal fatigue cracks in the analyzed zone of the roller surface (1) and at depths of 0.8 (2), 1.2 (3), 1.4 (4), and 2.0 mm (5).

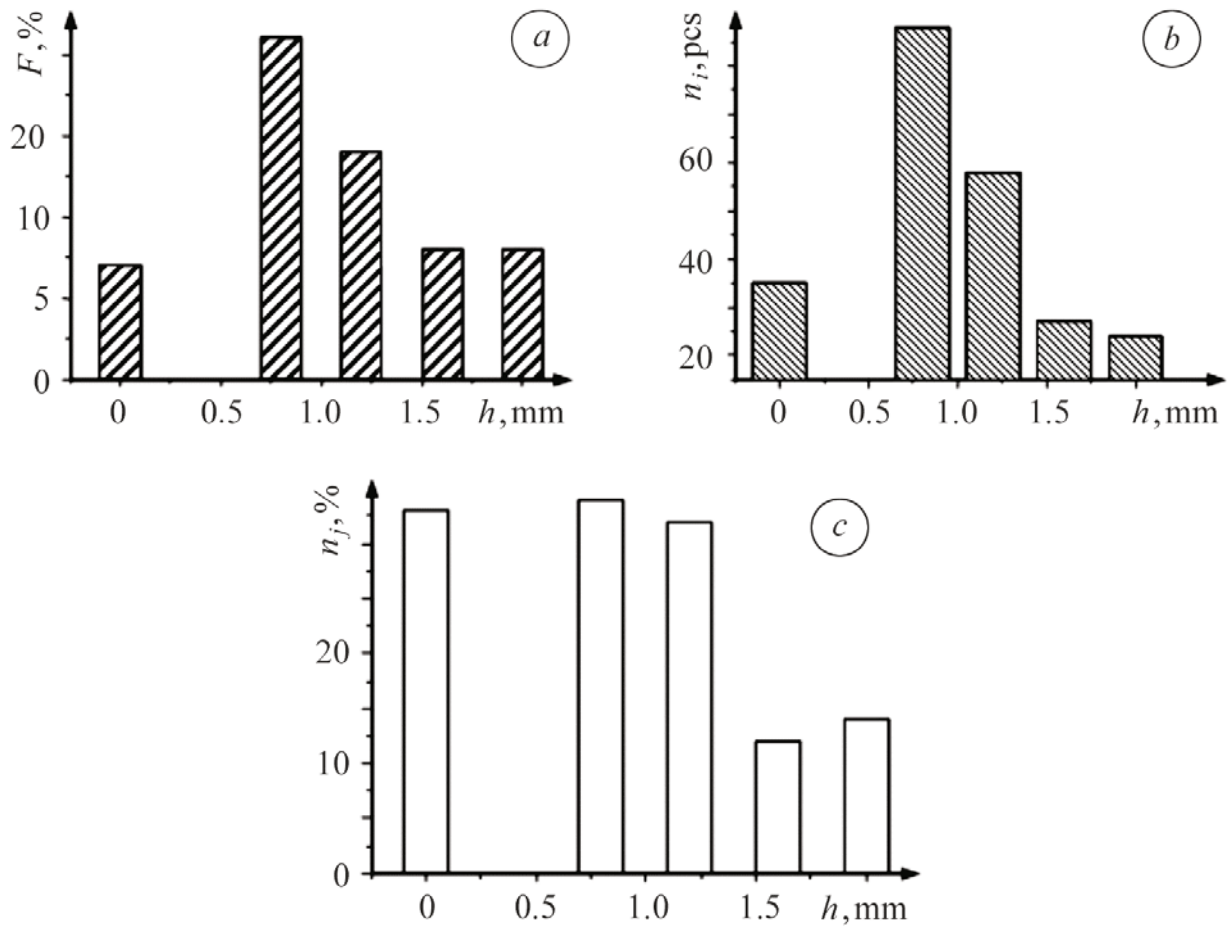
Fig. 4. Parameters of cracking at different distances from the roller surface: (a) relative area occupied by the cracks (%), (b) number of detected cracks (pcs), (c) number of combined cracks, %.

The numbers of cracks of this sort (n_j) detected on the surface and at a depth of 0.8 mm are constant. This means that the analyzed parameter is stable even on the oxidized surface (Figs. 4b and c). This is explained by the fact that coalescence is mainly observed for the longest cracks well identified under the proposed conditions [12, 13]. At depths of 1.2–1.6 mm, the specific fraction of combined cracks decreases from 30 to 13–15%. This is explained by the geometry of the crack. Indeed, they are almost round down to a depth of 4.0 mm but become semielliptic at larger depths [1].

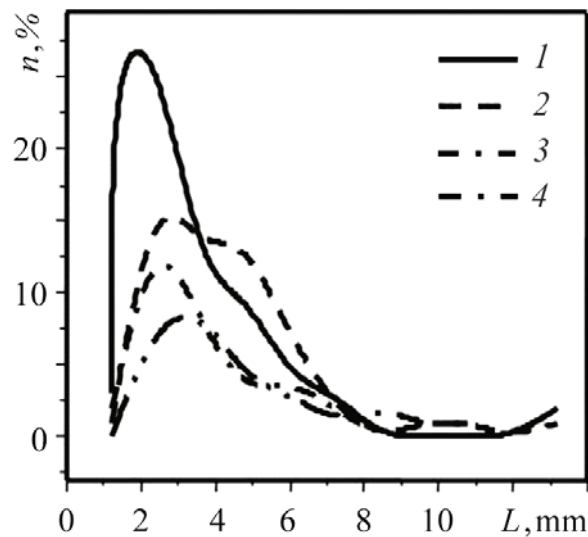
Fig. 5. Distributions of the number of detected cracks over the surface of the roller (1) and at the analyzed depths: (2) 0.4, (3) 0.8, (4) 1.2 mm.

In the investigated part of the roller surface, we discovered 35 (15%) individual cracks. If a thin surface layer is removed by grinding (in the case of incomplete removal of oxidized surface domains near the cracks), then the number of cracks rapidly increases. At a depth $h = 0.8$ mm and in deeper layers, the number of revealed cracks monotonically decreases as a result of the removal of the most cracked layer. We analyze the distributions of crack lengths L on the surfaces located at various depths h (Fig. 5). Thus, the lengths of the maximum number of cracks $L = 2.0$ – 3.0 mm, and the length of the deepest cracks is equal to 13.0 mm.
