RESULTS OF THE TECHNICAL SURVEY OF THE HISTORICAL ARCHIVE OF UKRAINE AT SQUARE SOBORNIY IN LVIV

Abstract. The article highlights the results of the technical inspection of the Central State Historical Archive of Ukraine building on the 3a Soborna sq., Lviv. The building was built around 1620. It is an architectural monument of national importance and an integral part of the architectural complex, including the Bernardine church. The building is attached to the northern wall of the church, and from the east, it is surrounded by walls with an entrance tower. The portals of the 17th century have been preserved in the interior and fragments of 18th century paintings. In the plan, the building has a complex configuration, and its body covers a square inner courtyard. The building is made of brick, three- and partly four-story. The walls are reinforced with stone buttresses. Tracking indicators of the technical condition of the load-bearing structural elements of the building makes it possible to determine the technical condition of individual elements and the building as a whole [1].

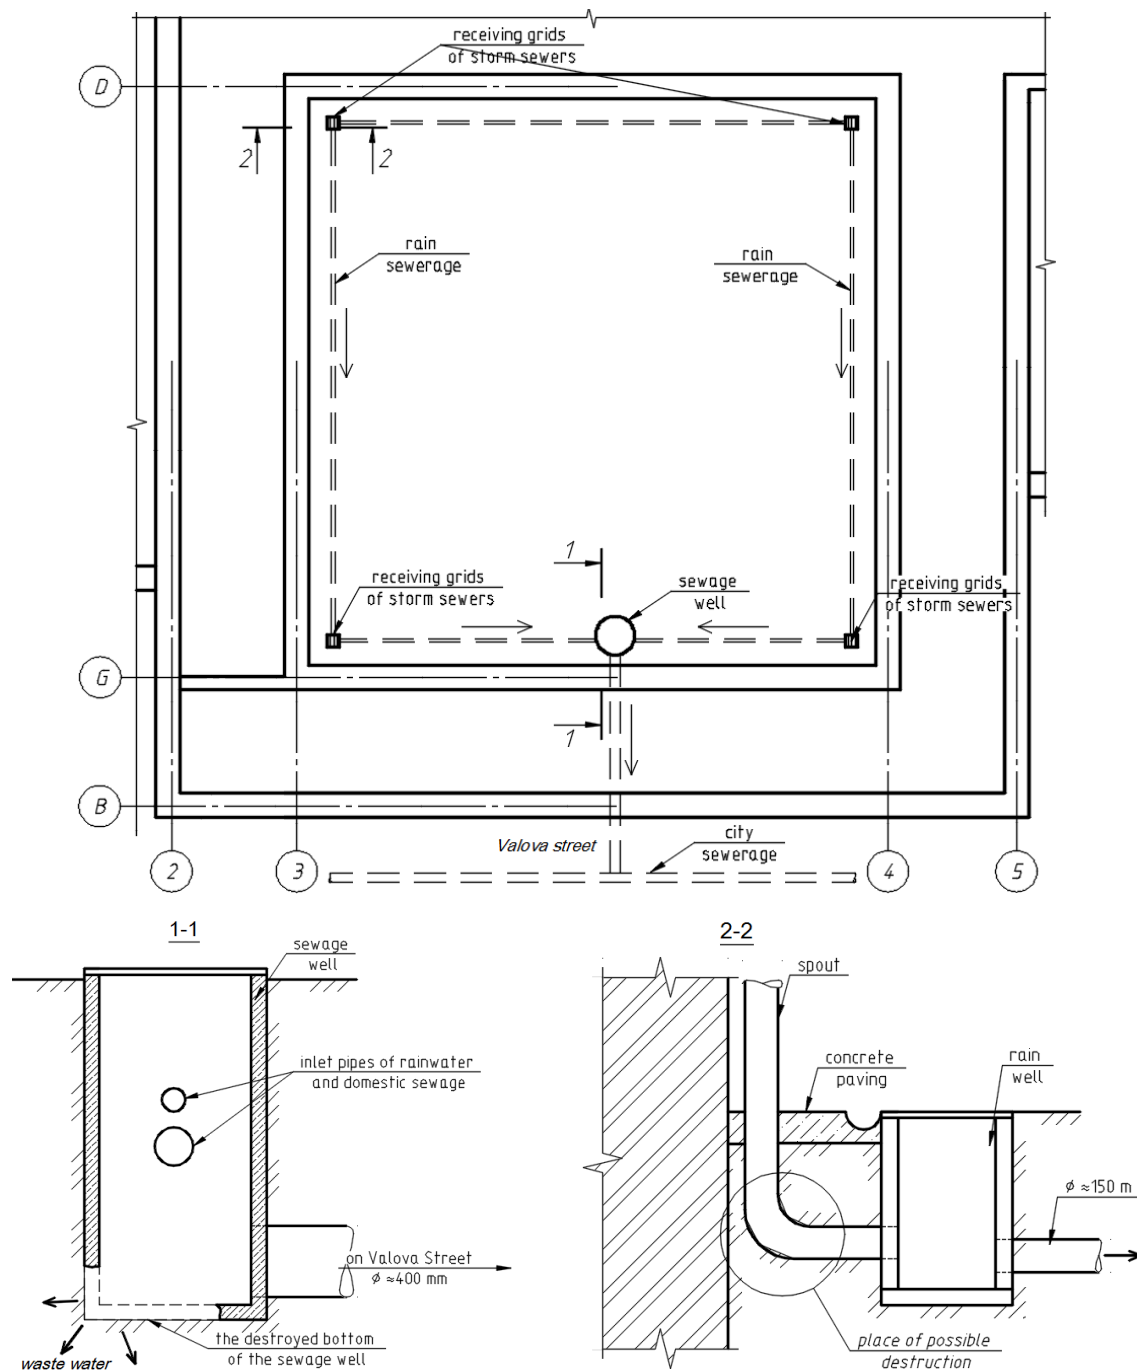
Figure 2. Water drainage scheme from the archive building

The survey revealed that the bottom of the well near the G axis is practically destroyed, and all the water penetrates under the foundations (Fig. 2, 1–1). An additional reason for the jamming of the bases under the foundations can also be the destruction of the elbows of the downpipes (Fig. 2, 2–2) in the places where they adjoin the drainage wells of the storm sewer. Water removes clay and dusty soil particles from the foundations layer by layer – mechanical suffusion occurs, destroying the soil structure and its subsidence. When the minerals of the soil skeleton of the base are dissolved, chemical suffusion takes place, which worsens the physical and mechanical properties of the soil. The presence of such damage over a long period reduces the bearing capacity of foundations (soils) and foundations. Uneven subsidence of the base was detected, as evidenced by the deflections of the floor of the first floor between axes 4...5 along axis D (Fig. 3), as well as in the places where water or sewage communications pass between axes 4...5 and G...D.

For further safe operation, the bottom and walls of the drainage well should be restored along the G axis; an audit of the drainage system; check the tightness of the connection of drainage pipes on the roof and at the point of entry into the sewage system, in places of floor subsidence, disassemble stone slabs and check the integrity of the pipe, if necessary, replace the pipe. The load-bearing walls of the building are made of brick, with a thickness of 75...100 cm between the first and third floors and 45 cm on the fourth floor. Partitions are made of brick with a thickness of 14 cm.

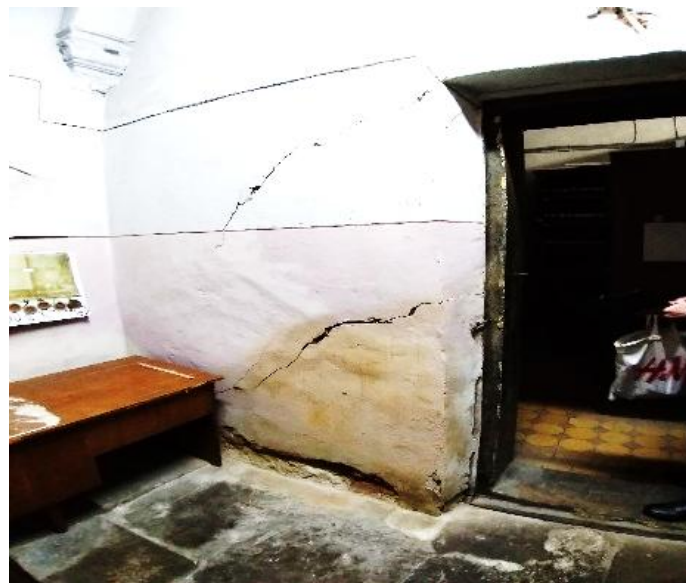
Figure 3. Oblique cracks in the wall with a width of up to 2 cm, floor deflection within the first floor between axes 4...5

According to the classification features of the technical conditions, part of the base in axes 3...4 along the G axis is in an emergency 4 and unsuitable for normal operation condition – 3 technical condition. The rest of the base is in a satisfactory condition – 2 technical conditions.

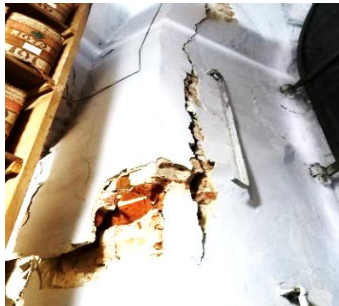
The examination revealed a vertical crack on 2/3 of the height with an opening width of up to 4 cm along the G axis within the first floor (Fig. 4). The crack continues to the arched lintel and ceiling. Cracks in the wall along the G axis, extending to the lintels and overlaps, were found along the entire length of the wall (Fig. 5, Fig. 6). Also, cracks in the wall extending to the floor were found on the parallel wall along the B axis. Oblique cracks with an opening of up to 1 cm were found in the partition along the D axis between axes 4...5.

Figure 4. A vertical crack on 2/3 of the height, up to 4 cm wide, along the G axis

According to the classification of technical conditions for stone and reinforced stone structures, the condition of the brick load-bearing elements along the G axis is classified as an emergency – 4 technical conditions, and the rest of the walls belong to 2 technical conditions – satisfactory.

For further safe operation, it is necessary to strengthen the wall along the G axis according to the previously developed working project, to fill the cracks along the D axis between axes 4...5 with an injection solution, to appoint further observations of the development of cracks in the wall along the G axis.

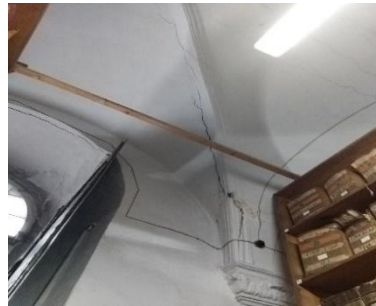
Figure 5. Cracks in the arched vaults of the floor and the lintel along the G axis

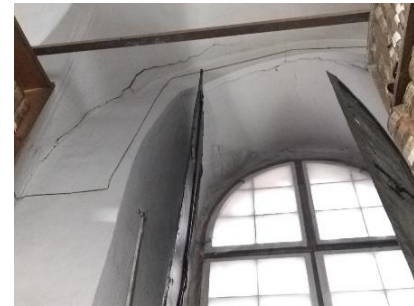
Figure 6. Cracks in the wall and in the arched lintel along the G axis

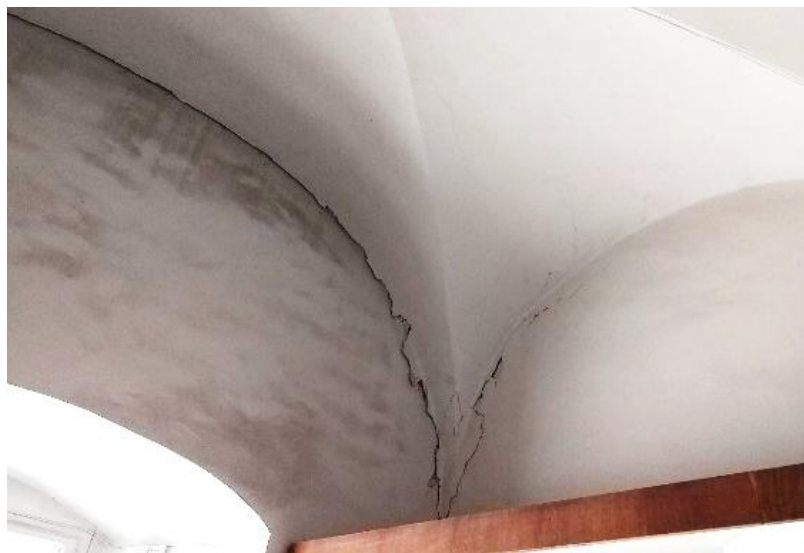
Most of the second and third-floor premises are after renovation, so no cracks were found there. In those rooms where the repairs have not yet been completed along the G axis, a crack was found in the place where the wall adjoins the floor (Fig. 7). According to the employees of the archive, before the repair, there were such cracks in all rooms of the second and third floors along the G axis. See the scheme of defects (Fig. 8).

Figure 7. A crack at the junction of the arched ceiling and the wall within the 2nd floor along the G axis

Identified cracks reduce the load-bearing capacity of the walls. The nature of the cracks and the geometric measurements that were performed indicate the loss of verticality of the wall along the G axis.

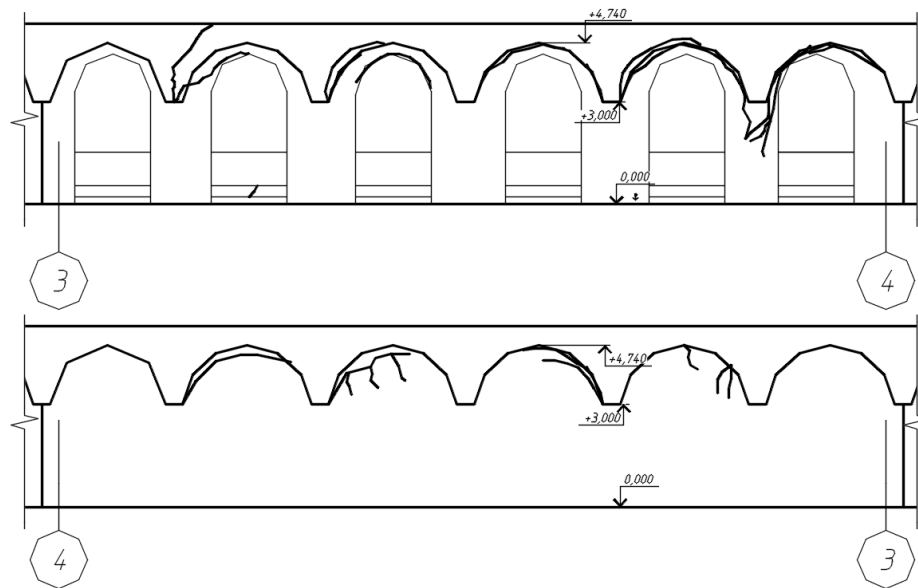
Figure 8. Scheme of defects along the B and G axes

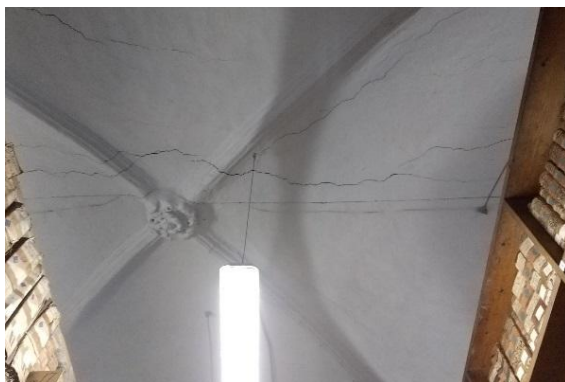
The ceiling is brick arched vaults. At the time of the survey, considerable defects were found in the arched ceilings of the first floor: cracks were found along the entire length between the axes B...G and 3...5 (Fig. 9), cracks in the wall along the G axis continue to the ceiling and arched lintels. A crack with an opening of up to 2 cm was also found in the place where the wall adjoins the ceiling within the 2nd floor along the G axis (Fig. 10). The nature of the cracks indicates the deviation of the wall along the G axis from the vertical.

Figure 9. Cracks in the arched ceiling within the 1st floor in the axes B...G

In general, the condition of the floor above the first floor in axes B...G 3...5 is classified as unsuitable for normal operation – 3 technical conditions for stone and reinforced stone structures. The rest of the floor is in a satisfactory technical condition.

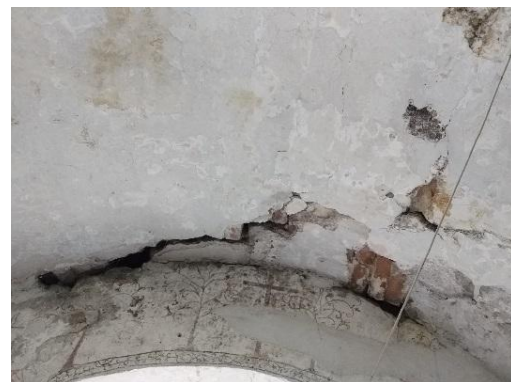
Figure 10. A crack with a width of up to 2 cm. in the place where the wall adjoins the ceiling within the 2nd floor along the G axis
