STRUCTURAL-FRACTOGRAPHIC INDICATORS OF OPERATIONAL DAMAGE IN STEAM TURBINE ROTOR DISC STEEL

Abstract. *The technical condition of the metal in a steam turbine rotor disk was analysed, and the causes of its failure were determined. It was shown that, despite the mechanical properties of 30KhN3M1FA steel meeting regulatory requirements under tension and impact, damage occurred in one of the rotor stages, leading to a forced shutdown of the rotor. Metallographic studies of the steel structure revealed an excessive amount of non-metallic inclusions, the high corrosive activity of which facilitated the dissolution of the matrix in their vicinity. These point defects became the sites of fatigue crack initiation. High contact stresses between the surfaces of rivets and holes in the rotor disk, and the constant increase in their relative displacement due to clearance violations during long-term operation, contributed to contact fatigue and the initiation of a network of microcracks in the vicinity of the holes. The string-like arrangement of structurally determined corrosion defects facilitated their coalescence, forming a continuous fatigue crack front. Its propagation culminated in the

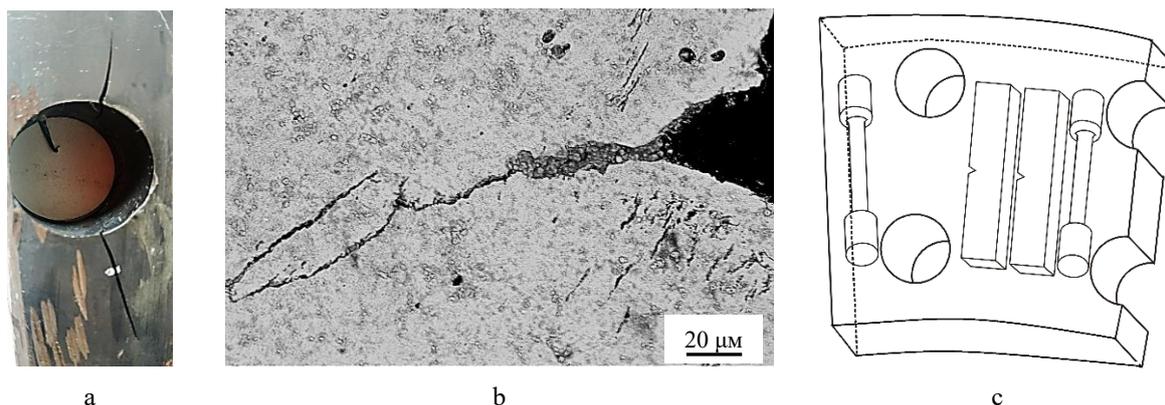
The fractures on the rotor disc's crest were located between adjacent rivet holes connecting the forked blade roots to the rotor disc's crest. Macroscopically, the cracks that developed in the bridges between the holes in the disk crest were oriented normally to the direction of the centrifugal forces generated during rotor operation. In the diametrical cross-section of these bridges that had not yet completely failed during operation, cracks originating from the rivet holes were detected (Fig. 1 a). At the microscopic level, these cracks were characterized by both macro- and micro-branching and a curvilinear propagation path (Fig. 1 b). Furthermore, the gap between their edges was filled with corrosion products formed as a result of the interaction of steel with the process medium during prolonged contact. All these signs indicate that the failure of the bridges between the holes occurred via a corrosion-fatigue mechanism, rather than as a result of spontaneous failure due to a single rotor overload. Taking into account the orientation of the operational fractures on the rotor disc crest, the mechanical properties of the steel were determined using specimens oriented radially relative to the rotor axis (Fig. 1 c). This was done to ensure that the macro-orientation of the specimen fractures and the operational fractures of the disk coincided. The results of the mechanical tests on these specimens showed that their σ_{UTS} and σ_{YS} values were 773 and 653 MPa respectively, δ and ψ were 22 and 71%, and KCV was 1,64 J/cm². All these indicators did not exceed the requirements of the industry technical specifications TS 108.11.918-87. Thus, despite the compliance of the rotor's operating conditions, the steel's chemical composition, and its mechanical characteristics with the regulatory requirements, the rotor disc still failed.

Figure 1. Macro- (a) and microscopic (b) view of cracks from a rivet hole and scheme of cutting samples (c) from the crest of a steam turbine rotor disk

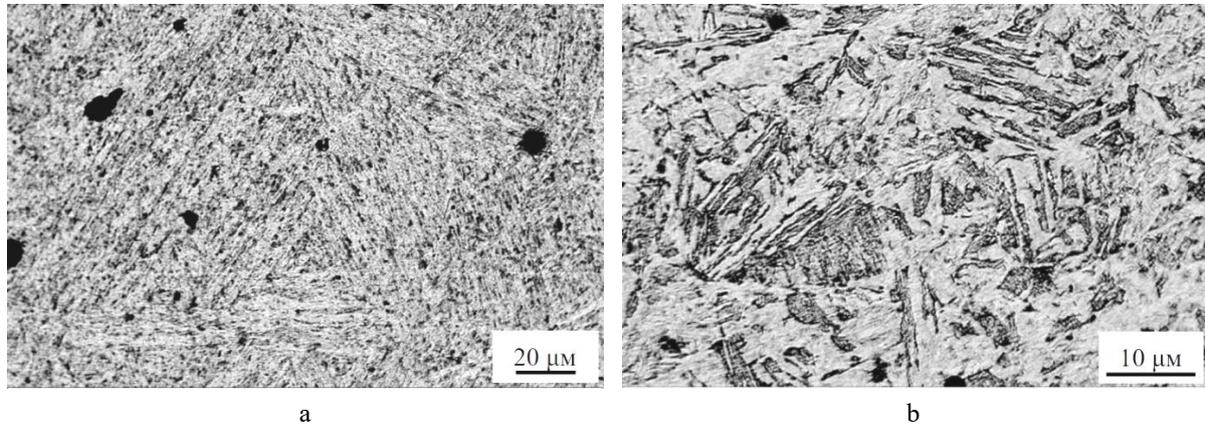
Metallographic studies of the structure of 30KhN3M1FA steel in the diametrical cross-section of the disc revealed typical morphological signs of highly tempered martensite (Fig. 2), which were more clearly identified at high magnification. The characteristic orientation of packets of practically parallel martensite laths changed during the transition from one austenite grain to another, within which they were formed. A feature of the structure was also an excessively high number of quite large (up to 15 μm) non-metallic inclusions, the high density of which was more clearly revealed at lower magnifications (Fig. 2 a). In the structure of the analyzed disc, their density was several times higher than the acceptable value for rotor disc metal (up to 2–3 particles per 1 mm² of polished surface area).

Figure 2. Structure of 30KhN3M1FA steel in the diametrical cross-section of the rotor disk crest

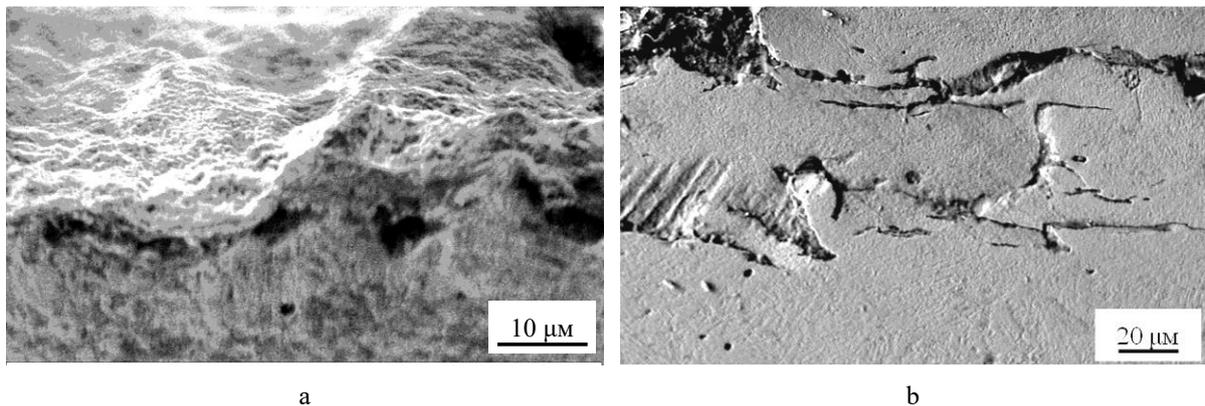
of these inclusions created the preconditions for the localization of deformation processes in areas with their high density. Indeed, the corrosive pits that formed on these inclusions (due to the dissolution of the inclusions themselves or the matrix around them) acted as structural stress concentrators. They were observed even near the transitions from the surface of the rivet holes in the disk crest to the surface of its fracture in the form of unidirectional rows of corrosive defects connected by a crack parallel to the fracture and located directly below it (Fig. 3 a).

Figure 3. Banded arrangement of corrosion pits of corrosive pits initiated by non-metallic inclusions on the surface of the rivet hole (in the lower part of the image), in the vicinity of its transition to the operational fracture surface (a), as well as typical contact fatigue cracks found on the diametrical polished section of the rotor disc crest under the surface of the rivet hole (b)

Such cracks are typically associated with contact fatigue. They are usually inclined relative to the contacting surfaces, and therefore, in cross-section, they appear parallel to them. The growth of contact fatigue cracks occurred through the destruction of the bridges between the closest non-metallic inclusions, which confirmed their negative role in the nucleation of damage (Fig. 3 b). Both the number of such cracks and the depth at which they were detected under the hole surface increased closer to the zone from which the disc crest failure occurred. Due to the action of high contact loads, cracks located at various distances from the hole surface in the disc crest connected via a shear mechanism, destroying the bridges between the nearest non-metallic inclusions. The transformation of one of these cracks into a main crack was accompanied by its reorientation (to one radially oriented relative to the rivet hole) and subsequent propagation under the action of cyclic tensile loads, but now as a crack oriented normally relative to the direction of the centrifugal forces acting on the disc.

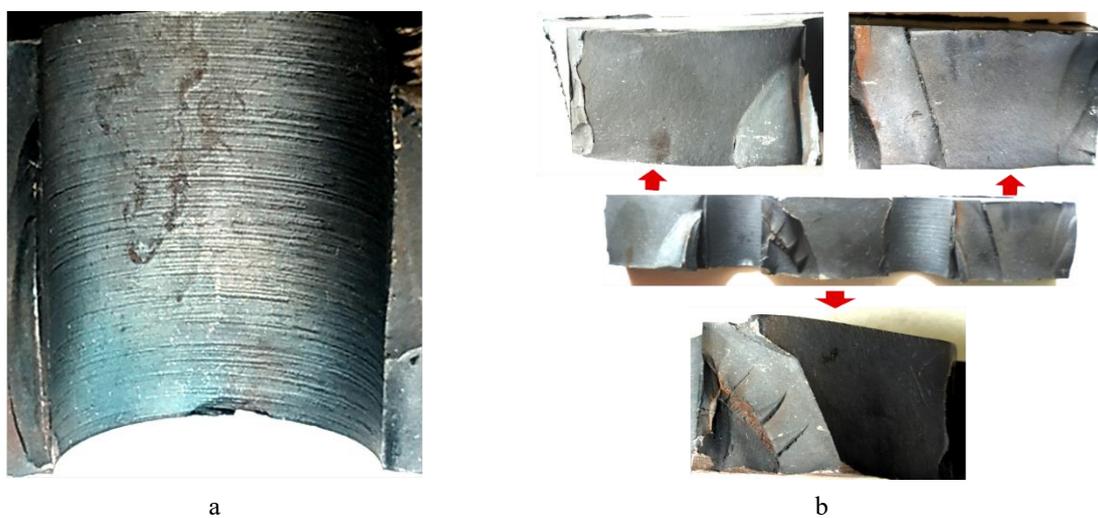
During the visual inspection of the damaged elements of the disc crest, traces of contact fatigue were also found on the inner surface of the rivet holes in the damaged disc, in the form of a crack on the steam inlet side to the stage (Fig. 4). The crack is oriented along the axis of the hole (across the traces of rough machining on the hole surface). Along its growth path, corrosive pits caused by non-metallic inclusions were detected. It was these pits that determined the curvilinear propagation trajectory of the contact fatigue crack, which propagated from one pit to another. A significant portion of these inclusions, based on their elemental composition, are classified as corrosion-active non-metallic inclusions [13]. These non-metallic inclusions contributed to the active dissolution of both the inclusions themselves and the matrix phase in their vicinity when moisture entered the contact zone of the rivet surfaces and the holes in the disc crest. Taking into account the micro-displacements of the rivets relative to the hole surfaces in the disc, these local structural defects facilitated the formation of a network of fine microcracks initiated from them.

Figure 4. Traces of rough machining on the inner surface of a rivet hole formed during the disc manufacturing stage, and the curved trajectory of a contact fatigue crack propagating along the axis of this hole (a, in the upper photo), as well as typical features of macro-fractures in the bridges between the closest rivet holes in the crest of the steam turbine rotor disc (b)

To limit the movement of the blade roots and the disc crest along the rivets, the rotor disk assembly technology included cold heading of the rivet ends at the exit of the holes.. However, due to non-compliance with the requirements for the cleanliness of the contact surfaces and the gaps between them, which only increased during the operation of the rotor, the circumferential movements between the rivets and the disc crest became increasingly easier, and their amplitude grew. As a result of the intensive deformation of the metal's surface layers under the surfaces of the rivet holes, the microcracks from corrosive pits on the non-metallic inclusions connected, and longitudinal contact fatigue cracks formed on the surfaces of the holes.

Macro-level analysis of the fractures in the bridges between the rivet holes showed that all failures began in the form of angular segmental cracks on the steam inlet side of the stage (Fig. 4). Their relatively smooth morphology at the initial stage typically ended in a rough final fracture with characteristic brittle tear ridges, corresponding to the overload stage upon reaching a critical state.

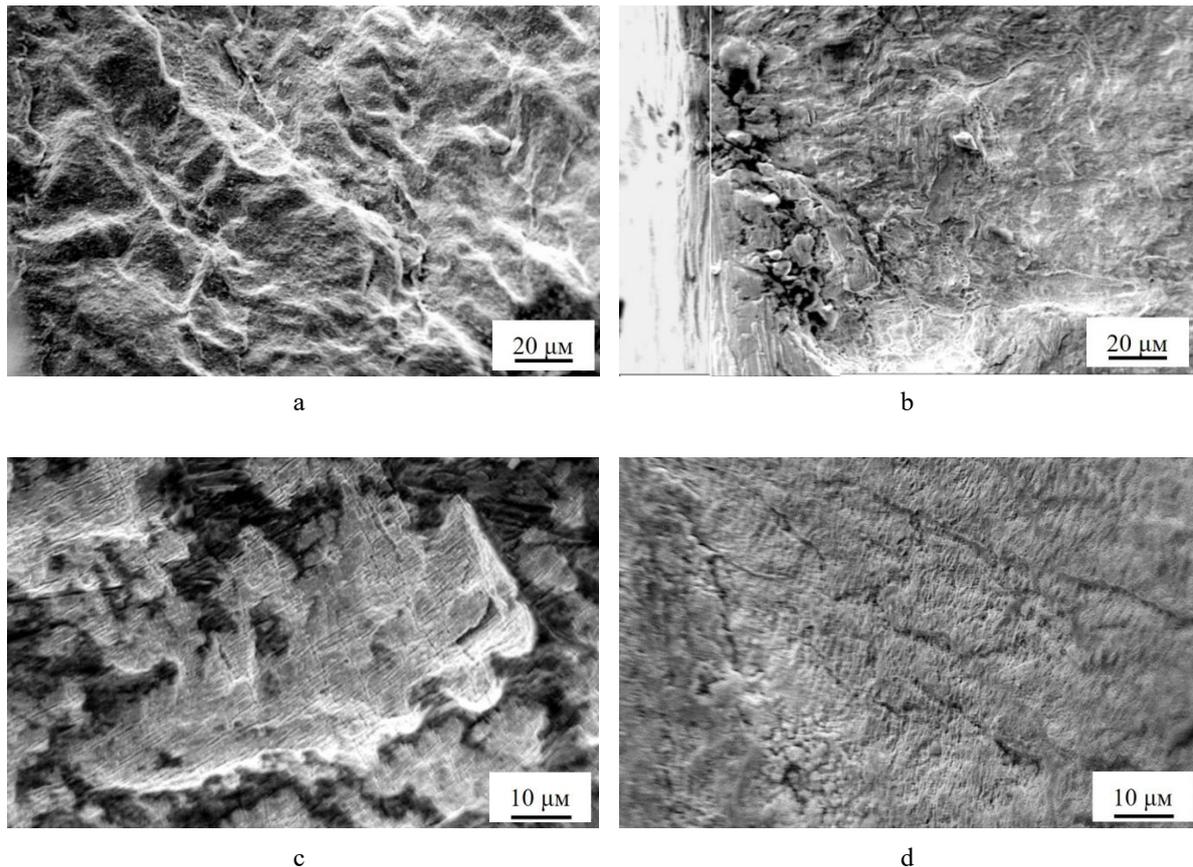
microscopic level (Fig. 5 a). This was considered direct proof that the fractures were exposed to the high-temperature process medium for a long period, and therefore, their formation did not occur instantaneously due to overload but over a long period of the disc's service life. However, even in this state, quarter-circular marks were visible on the fractures, densely decorated with rows of circular pits (up to 5 μm in diameter), which formed due to the corrosive interaction of non-metallic inclusions with the process medium. The same pits decorated the front of the propagating fatigue crack at each subsequent stage of its growth. Based on this, it was concluded that inclusions in the steel structure (as a result of imperfections deoxidation process, incomplete homogenization of the solid solution, etc.) play a decisive role in reducing its fracture resistance.

Figure 5. Typical fractograms of fractures of the bridges between the holes in the disc crest at the fracture initiation stage by the contact fatigue mechanism (a, b) and at the stage of further propagation of a fatigue crack by the fatigue striation mechanism (c, d)

Even partial cleaning of the fractures revealed a series of parallel cracks on the surface of the rivet disk hole, visualised by opening their edges (Fig. 5 b, parallel steps in the lower left corner of the fractogram). Secondary cracks, decorated with

non-metallic inclusions, are clearly visible on the fractures of the disk crest. These cracks are traces of contact fatigue cracks, propagating from the surface of the rivet holes to their intersection with the fracture surface. These secondary cracks were not considered to be traditional branches of the crack in the direction of its propagation, which, as a rule, relax the stress at their tips and slow down their growth. However, these cracks most likely represented alternative fracture initiation pathways from the hole surface, intersecting the fracture but behind the main fracture front. In our case, this is an effective way to visualise contact fatigue cracks in the fractures of the bridges between the rivet holes.

After repeated cleaning of the fractures, it was possible to confirm that the crack initiation stage via the contact fatigue mechanism from the rivet hole surfaces in the disc crest gradually transitions to its propagation via the high-cycle fatigue mechanism. According to the results of the analysis of the fracture of the bridge between the holes in the damaged fragment of the disc crest at the stage of the angular quarter-circular crack propagation from the steam inlet side, typical signs of fatigue failure were discovered (Fig. 5 c, d). The most important of these was the presence of parallel rows of fine fatigue striations located across the festoons, extending in the main direction of fatigue crack propagation. These striations were the traces of the crack's stage-by-stage advancement during each load cycle of the disc.
