# Features of the fracture of the control valve rod of a thermal power plant steam turbine

**Abstract:** *The reasons for the failure of the steam turbine control valve rod after 17 years of operation were analyzed. It was found that its fracture began in several places along the perimeter of the rod, followed by coalescence and subsequent spontaneous failure. Fractographic analysis showed that the crack propagated via a high-temperature fatigue fracture mechanism. Impact toughness, strength, and ductility properties determined on axial steel specimens of the control valve rod complied with regulatory requirements. However, the parameters of transverse specimens made from the rod head were lower. A decrease in all these characteristics was also observed in the high-temperature operating zone compared to the low-temperature zone, indicating more intense metal degradation. The control valve rod had 12091 operating hours and 206 shutdowns, which significantly impacted this process. Macrofractographic analysis showed that the rod fracture occurred because of multiple microcrack initiation in the nitrided layer along the perimeter in the zone of the fillet transition (stress concentrat

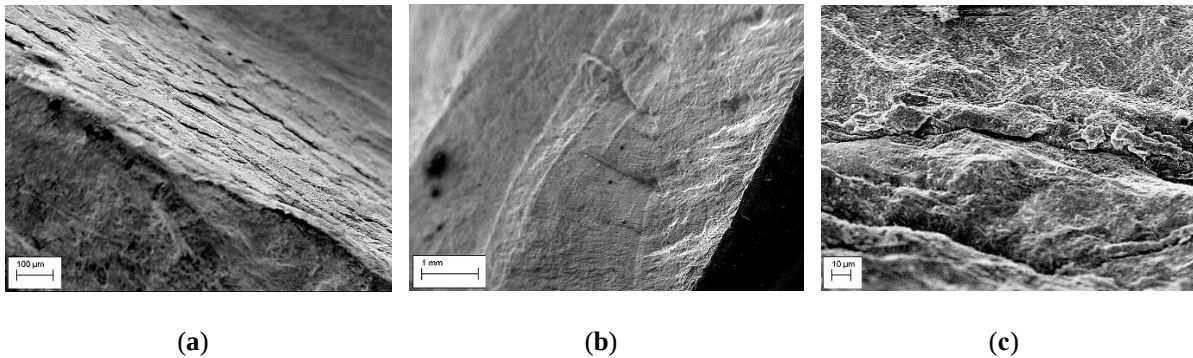
Microfractographic analysis showed that the initiation of a crack in the rod occurred in several places along its perimeter from damage in the surface nitrided layer in the area of the fillet transition between the conical part of the rod and its head (Fig. 1). Damage in the nitrided

layer spread to its entire depth (up to 200  $\mu\text{m}$ ) and caused a high concentration of stresses. This created favorable conditions for the propagation of fatigue cracks in the main metal of the rod. Macro-detail of the fracture indicates that fatigue is responsible for the rod failure. Secondary cracks were observed along almost the entire perimeter of the rod at the transition, which is a sign of weak adhesion between them, which was associated with internal oxidation (Fig. 1c).

**Figure 1.** (a, b) Crack initiation in different zones around the rod perimeter; (c) secondary cracks on the fracture surface.

The fracture of the rod was analyzed macro-fractographically, and it was found that it collapsed due to multiple microcracks in the nitrided layer along the perimeter of the rod, in the fillet transition zone between its conical part and the head, which acts as a stress concentrator. Further, the crack growth occurred in the depth of the section with the merging of the fronts of separate cracks from the surface and the final spontaneous failure of the rod.

Thus, based on the study of the microfractographic features of the control valve rod fracture, it was concluded that it occurred as a result of the nucleation of circular microcracks in the nitrided layer due to its internal oxidation and the destruction of the partitions between the oxidized areas due to cyclic loading of the rod caused by vapor pressure drops, flow turbulence and resonance phenomena, when the natural frequency of oscillations of the rods coincides with the frequency of oscillations caused by the influence of technological factors. The high concentration of stresses at their tops, low resistance to high-temperature oxidation, and matrix destruction (due to the release of chromium carbides and a decrease in its content in the matrix) contributed to their germination into the rod base by the mechanism of multi-cycle fatigue. If the niobium present in the steel composition had performed its assigned function (to prevent a decrease in the chromium content in the matrix), the rod resource would have been much greater. Therefore, in the future, to prevent unforeseen damage to such critical structural elements as rods, incoming inspection of the steel structure is recommended.

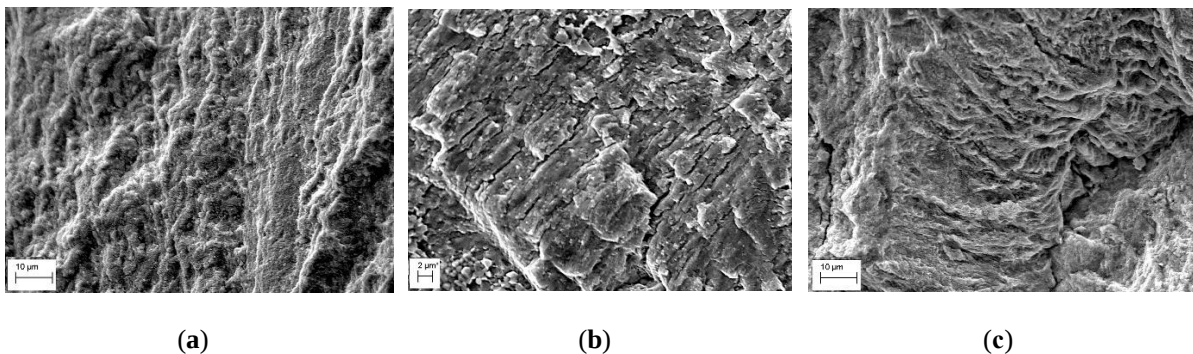
Within the nitrided layer, fatigue failure of the partitions between the fragments separated from the matrix by internal oxidation occurred, with the formation of a grooved relief oriented parallel to the outer surface of the rod and with signs of secondary cracking (Fig. 2 a). In areas corresponding to decohesion zones due to internal oxidation, traces of corrosion effects on the interphase boundaries between the matrix and inclusions of various nature were identified.

**Figure 2.** Microfractograms of rod fracture: (a) in the area of the surface nitrided layer; (b) at the stage of stable fracture propagation; (c) in the crack growth zone with high asymmetry of the loading cycle (at the stage of low-cycle fatigue).

At the initial stage of the transition of the fracture to the base metal, fatigue cracks originated from the blunted crack tip in the nitrided layer by forming a smooth relief with barely noticeable fatigue grooves. By the step of the grooves, it was established that at the initial stage of crack growth in the rod, their speed was  $5 \cdot 10^{-8}$  m/cycle. With increasing crack length, the contours of the grooves became increasingly clear, their step became larger, and the festoons, the surface of which was covered by the grooves, became more

relief. These are signs of an increase in the crack growth rate. The classical groove mechanism of fatigue failure was preserved in most of the rod fractures, which is usually considered a sign of multi-cycle fatigue (Fig. 2 b). Of course, the deeper the fracture spread from the lateral surface of the rod, the greater the pitch of the grooves, the deeper and clearer the secondary cracks that decorated them, and the greater the relief of the festoons.

Fatigue fracture in the base metal occurred with significant signs of plastic deformation, delamination, formation of chevron patterns, and track marks (Fig. 2c). It was assumed that the prerequisites for such a fracture arose due to the deepening of cracks in other places along the perimeter of the rod under conditions of multi-cycle fatigue. As a result of low-cycle fatigue, only the alignment of the fracture front occurred.
