HYDROGEN EFFECT ON FATIGUE LIFE OF A PIPE STEEL

J. Capelle, J. Gilgert, G. Pluinage

*Laboratoire de Fiabilité Mécanique**Université Paul Verlaine Metz et École Nationale d'Ingénieurs de Metz (France)*

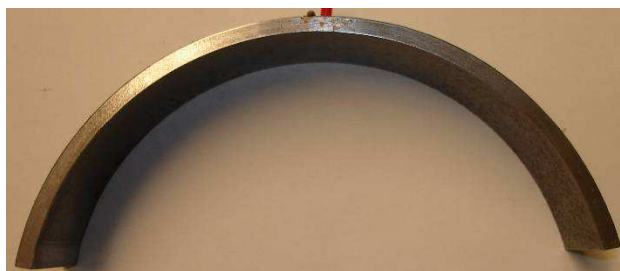
Picture 1 and 2: Sample used

The sample modelled hereafter in the picture 1 and 2, result from a gas pipe used in the Ukrainian network. It has an external diameter of 219,1 mm for a 6,1 mm thickness. As the pipe has a strong curve and a low thickness, it is not possible to produce traction or standardized bend-test samples. This is why we chose to carry out test on curved samples. These samples are cut in arcs of 160° for a width of 60 mm (the zone comprising the welding being avoided). The notch is used to reproduce the possibility that these pipes have to be scraped by machines (as excavator, digger, scraper,...). The notch in V at 45° is carried out on 20% thickness of the curved sample, it has a depth of 1,22mm. The ray of notch bottom is 0,15mm.
