Poliński, Ja. & Ochociński, K. (2016). Safety of visually impaired and partially sighted people on rail platforms in Poland – existing state and mistakes committed. *Socio-Economic Problems and the State*. 14 (1), 59-70.

Safety of visually impaired and partially sighted people on rail platforms in Poland – existing state and mistakes committed

Janusz Poliński *, Krzysztof Ochociński **

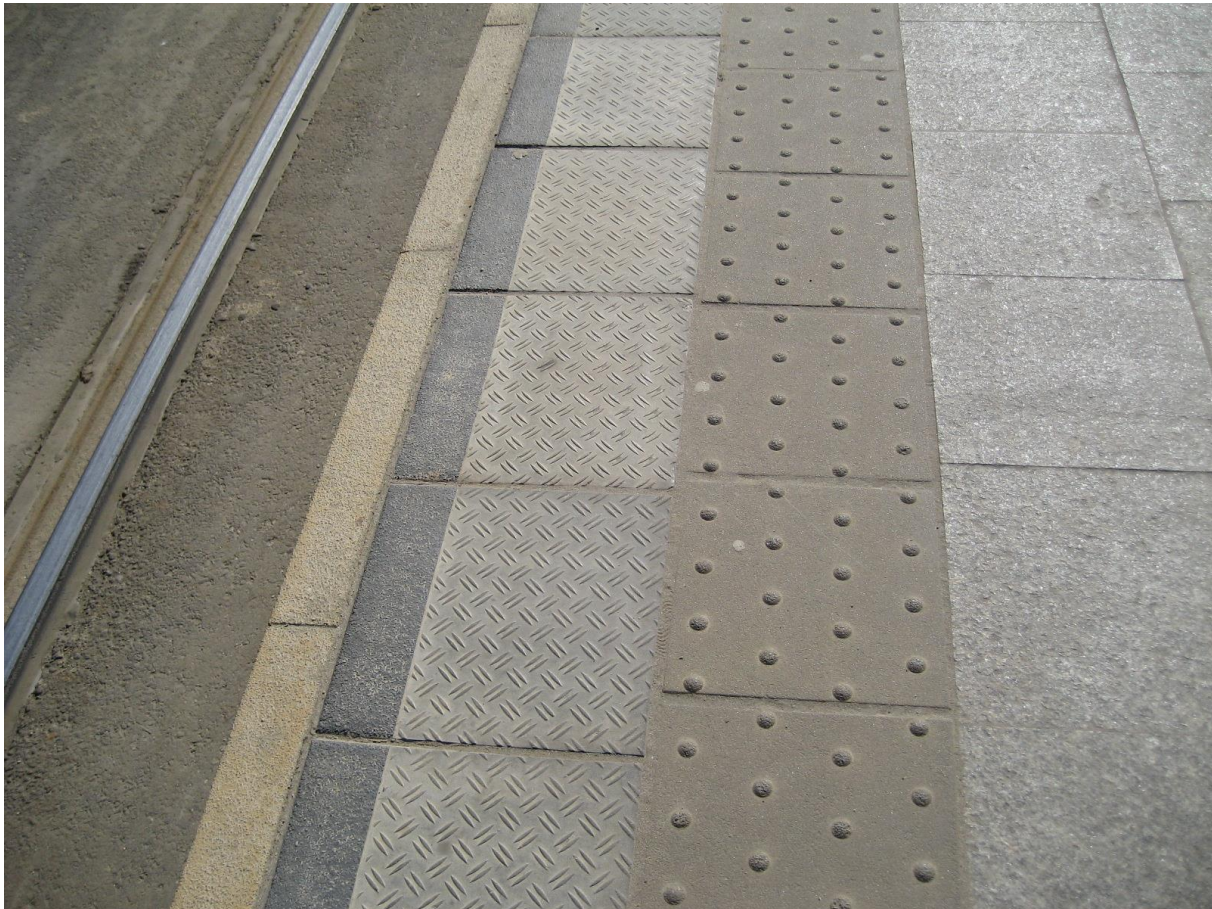
Figure 1. Examples of markings the edge of the tram platform in Warsaw taking into account the guidelines of the Polish Association of the Blind

Fig. 1 shows that correct markings of the platform edge is made using colored, small paving elements. In contrast, in Grudziądz there has been used a monolithic plates of non-slip textured surface with warning strips. Coatings have been applied on the plates according to the recommendations of Polish Association of the Blind. It is worth noting that in current regulation (Regulation 1999), in the § 120, which provides guidance for the tram platforms, recommendations have not been included for platform surface and its adaptation to the need of visually impaired and partially sighted people.

Examples of solutions are shown in fig. 1, taking into account the recommendations of Polish Association of the Blind.

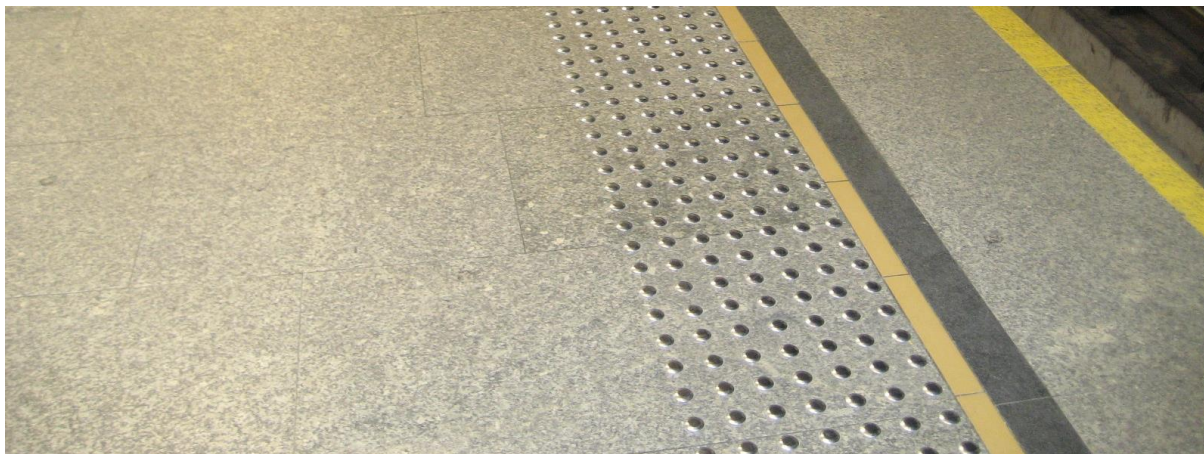
Figure 3. Markings of the platform edge at Warsaw Underground

It is worth noting that on the new platform stations - now finishing the central section of Underground Line II - there are applied tactile warning signs for visually impaired and partially sighted people according to the above mentioned Regulation. The view of the platform edges of Warsaw underground is shown on the fig. 3.
