## ASSESSMENT OF DESTRUCTION CONDITIONS OF THE LONG-TERM OPERATION GAS PIPELINE

**Summary.** For the long-term operation of main oil and gas pipeline steels the method of estimation the critical crack growth resistance  $J_{1c}$  of pipeline steels using experimentally obtained diagram of „force-deflection“ specimens destruction was proposed.

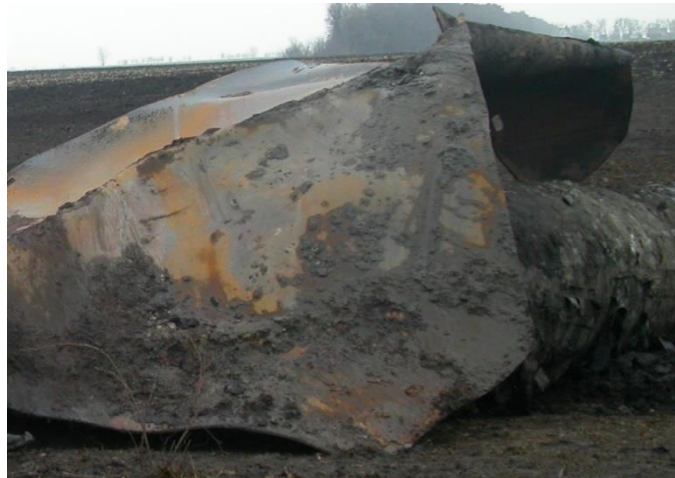
Despite the thorough complex investigations carried out at the main gas pipeline „Urengoi – Pomary – Uzhorod“ in May, 2007 in the area CS „Stavysche“ as a result of the corrosion cracking under stress (stress corrosion) of the pipe metal, there happened a destruction with the pipeline fracture. In this case the reason of the damage was the 6,8 mm depth and 740 mm length crack. The cause of the similar destruction, which occurred in December, 2007 in the area CS „Illinty“ (Fig. 1) was the 11,8 mm depth and 600 mm length crack [8, 9].

**Figure 1.** A typical example of a catastrophic destruction of the 1420 mm diameter pipe of the main gas pipeline Urengoy-Pomary-Uzhorod (2007 near the compression station Ilyinty)
